## The Woes of Termite Management

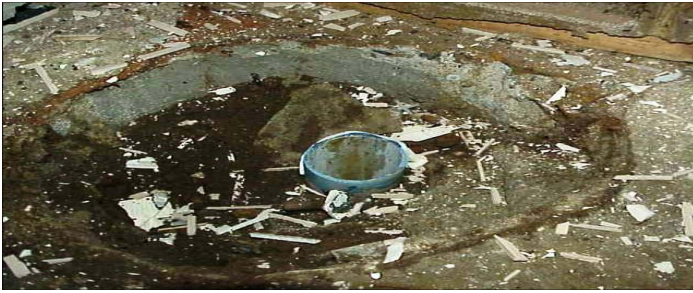
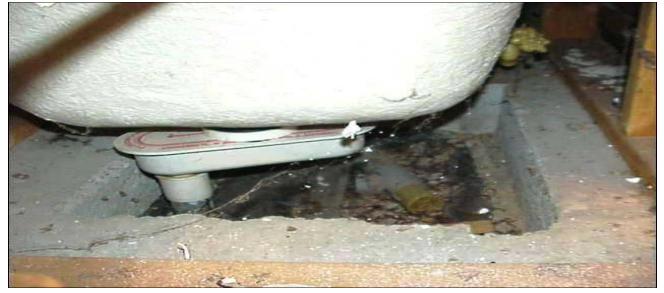
***Below Pictures showing “Block-outs” under a bath and a shower base where extensive termite ingress was found.***

The developers initially cleared the land and buried the cleared timber in the ground rather than burning off, so as to appease the active 'green' lobby. Small pine plantations were left standing to provide aesthetically pleasing timbered glade areas for residents. These glades also provided termites with ideal habitat conditions. Many homes were constructed with concrete slabs adopting waffle pod technology where polystyrene waffle pods were utilised to create above ground rafted slabs. The polystyrene was a strong attractant to termites and is often used in conjunction with termite baiting systems. The traditional in-ground concrete slabs were often constructed with 'block-outs' where significant sections of concrete were missing under baths and showers despite the slab being provided with barrier status in the Standard.

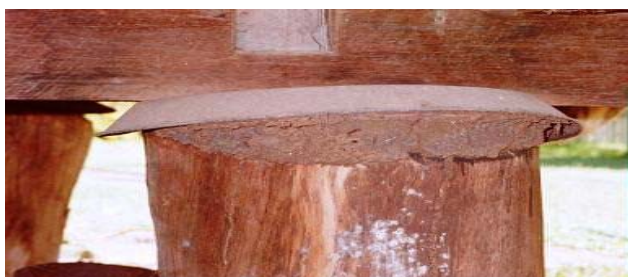
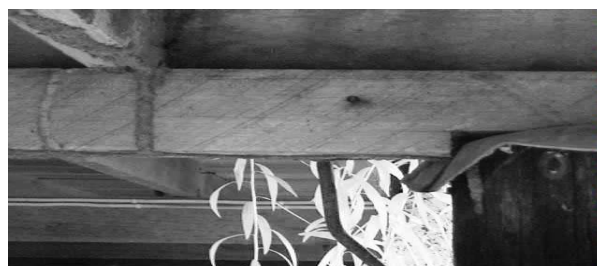
***Ant caps showing termite activity. Note that the activity has moved up on to the bearers and joists in Figure 2. The ant cap is unable to stop termite movement and is a monitoring system that assists in the detection of termite movement. All physical termite management systems operate in this manner.***

It should be noted that termites can cross the 75 mm inspection zone within minutes, do not encounter lippage, and be inside a home within a matter of hours. The problem with this situation is that termite inspections are generally an annual event. Many homeowners and property investors are provided with the mistaken belief that these systems provide protection because of the barrier status conferred on physical termite management systems by the Standard. This singular fact ostensibly defrauds Australian homeowners and property investors by allowing system manufacturers and providers to represent a simple termite monitoring system as a barrier system to termites.

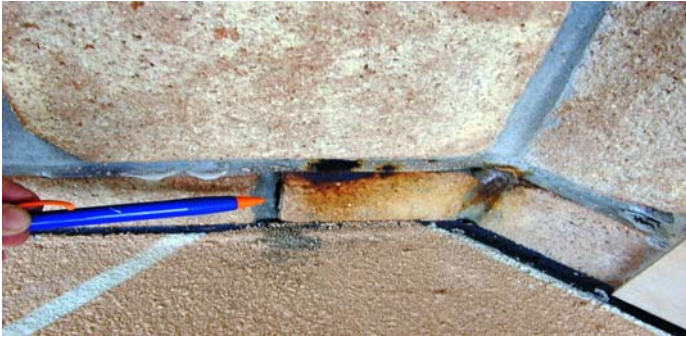
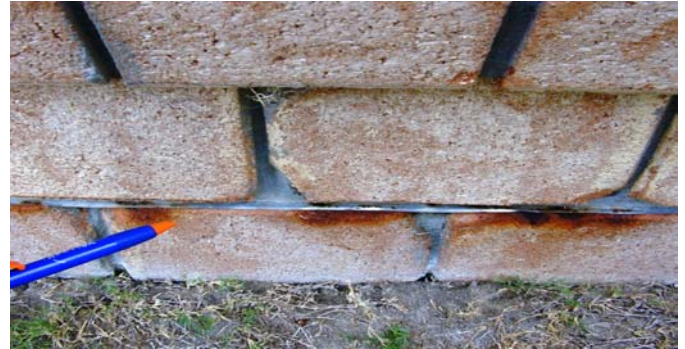
*Sheet metal termite management systems corroding due to the effects of salt, moisture and heat which cause crevice corrosion of the metal.*

The fact that the Standard contains no procedures or details on durability and fails to provide 'barrier' assessment criteria for termite management systems that are generally incorporated into the construction of a dwelling should be cause for extensive concern for architects and building designers who specify termite management systems, building surveyors who certify these systems, builders who incorporate and integrate these systems into the construction of a dwelling, system manufacturers who provide these systems and pest managers who are required to service and inspect these systems. Many of these systems are breaking down or corroding because of their application in the cavity of homes where they are subsequently sandwiched internally between mortar and bricks. The CSIRO has requested that Standards Australia address the durability issue in any new Termite Management Standards.
